Drawn by SP9XE
Based on original microphone

Sheet: /		File: BAMS microphone diagram.kicad_sch	
Title: PRC600 / BAMS handpiece (microphone)			
Size: A4	Date: 2026-04-09	Rev:	
KiCad E.D.A. 8.0.7			Id: 1/1

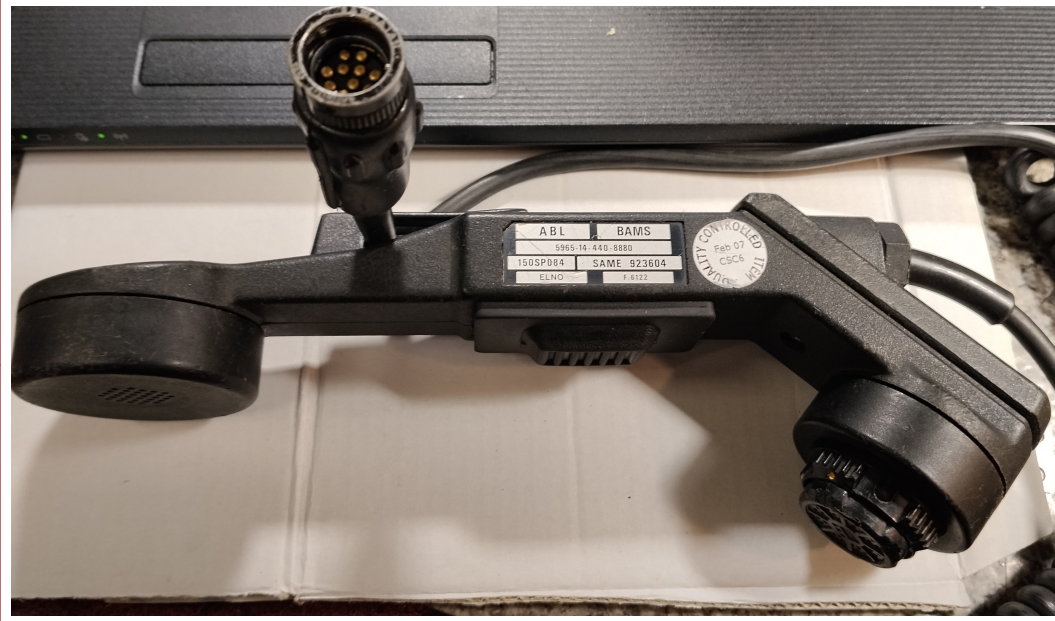
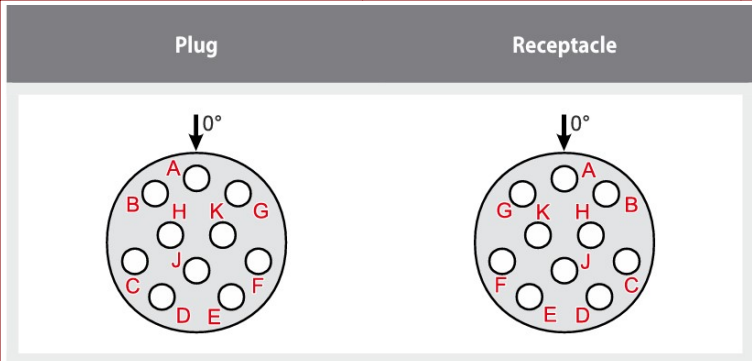
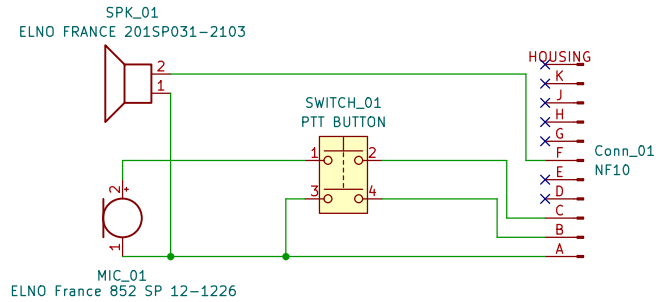
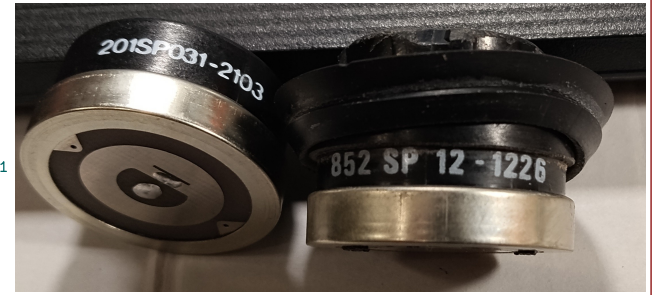
1. Connection between Speaker, Microphone and pin of PTT button seems to be connected together directly in NF10 plug
2. Measured resistance: Speaker around 66 Ohm, Microphone around 120 Ohm
3. Common issue with handpiece is related to old style switch resolved on contact plates due to long usage plates tends to stop working – handpiece tends to create "screeching" noise Might be required to adapt different handpiece or modify contact switch with different type.
4. There might be a possibility to adapt old telephony relays to use as contact plates however problem here is that original plates are molded in plastic – no possibility to disassembly Carefull adaptation is required in that case – especially in terms of electric connections.
